BOARD OF INQUIRY OR UNIT INQUIRY  
INTO AN  
AIRCRAFT ACCIDENT OR OTHER OCCURRENCE

for the purpose of<sup>3</sup> Investigating the sequence of events, circumstances and causes of the accident involving Lynx ZE 380 of the Northern Ireland Regiment Army Air Corps on 13 February 1991.

document ID:	D473693	document type:	WISREP
title:	12.7MM HMG SHOOT/FORCED LANDING OF LYNX HELICOPTER		
DOI:	13/02/91	TOI:	15:18
classification:	RESTRICTED	dsl:	3
originating unit:	3WIS/ARM	dated:	13/02/91
location name:	REAR OF COMMUNITY CENTER	grid ref:	H91251515
street:	MILL	type:	LANE
town:		town:	CROSSMAGLEN
grade/reliability:	■	area:	03
		D&D control:

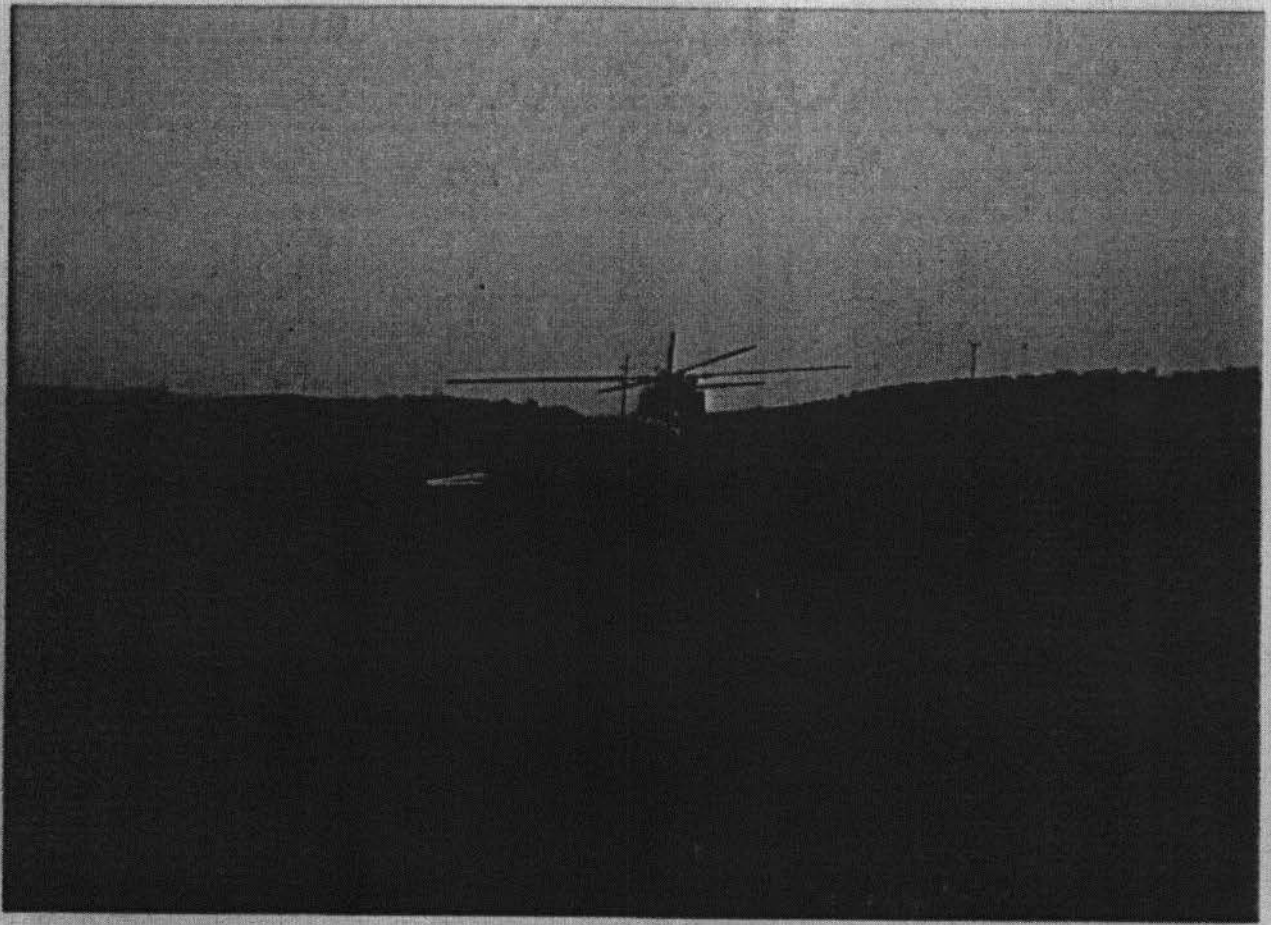
0

1. VIEW OF HELICOPTER ON FORCED LANDING.
2. [REDACTED]
3. [REDACTED]
4. [REDACTED]
5. [REDACTED]
6. [REDACTED]
7. [REDACTED]
8. [REDACTED]
9. [REDACTED]
10. [REDACTED]
11. [REDACTED]
12. [REDACTED]
13. [REDACTED]
14. [REDACTED]
